AN INVESTIGATION INTO THE EFFECTS OF
AN HERBICIDE ON HISTORIC MASONRY
MATERIALS

A THESIS

Historic Preservation

1999

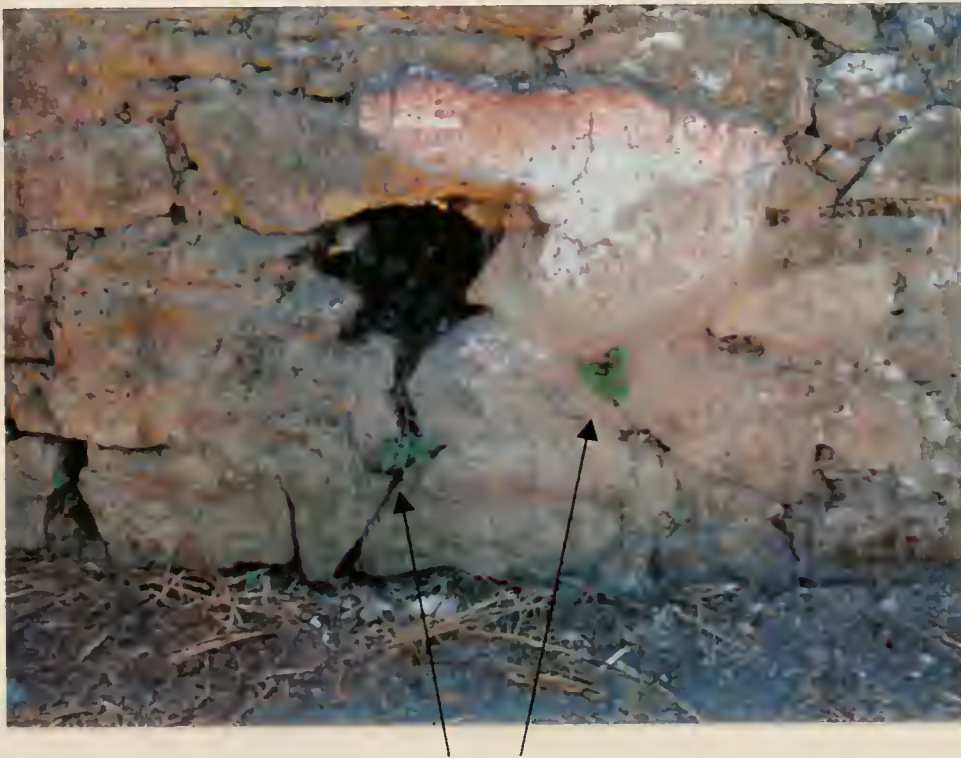
Figure 1: Small plants growing in joints

Some consequences of root infiltration include dislodgment of facing stone and plasters, and the formation of new cracks or the enlargement of existing cracks.¹⁴ Removal of a weak substrate or mortar is also a function of plant damage.¹⁵ Penetrating roots can also enlarge pores that act as a starting point for freeze/thaw and other mechanical damage.¹⁶ Large woody plants that are intertwined with the wall also pose a serious threat. If the plant is removed by man or nature, the wall can be pulled apart. Roots also retain moisture contributing to lower mechanical strength displayed by many masonry materials when wet.

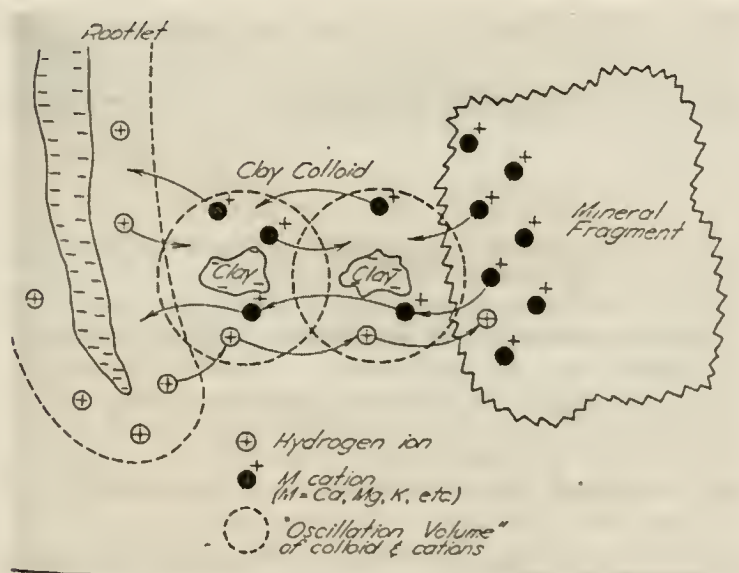
Figure 2: Diagram of hydrogen-mineral exchange between plant roots and mineral (reprinted from Keller and Frederickson)

The process of chemical weathering, as related to plant activity, has been investigated and described by Keller and Frederickson. The root surface is “enveloped by hydrogen ions which are chemically aggressive to minerals due to a greater chemical potential energy arising from their high electrical charge per unit volume.”²⁰ As the root advances into a void of the rock, this characteristic destroys tangential mineral compounds. The hydrogen ions invade the fractured lattice at the crystal boundary and displace sodium, calcium or potassium, which are absorbed by the root as nutrients.²¹ As the plant removes these minerals and replaces them with hydrogen ions at the surface, it restores the original

concentration of hydrogen ions.²² The replacement of sodium, calcium or potassium ions by H^+ ions destroys the stability of the lattice because of the difference of coordination between the H^+ ions and the metal cations.²³ Hydrogen ions are easily exchanged for nutrients because of their small size and their high-energy chemical properties arising from a large charge for a small particle.²⁴ Carbonate materials tend to be more susceptible to weathering because of their sensitivity to acid attack.

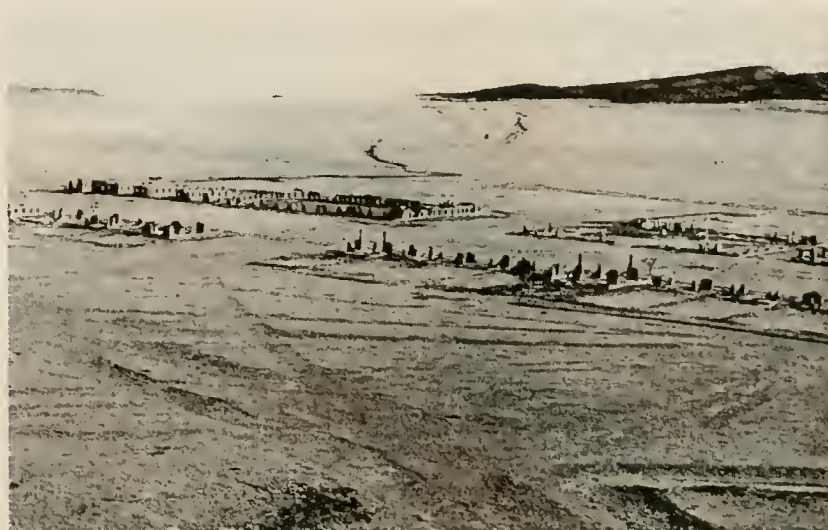
Figure 4: Fort Union National Monument (reprinted from Robert M. Utley, *Fort Union and the Santa Fe Trail*)

Although vegetation at Fort Union has not appeared to cause any significant damage to the walls, the displacement and cracking of floor bricks are one result of extensive plant growth at the site. Vegetation at Fort Union consists primarily of grasses and herbaceous plants. Vegetation includes gramma grass (*Bouteloua oligostachya*), blue gramma, sideoats gramma, galleta, Switch grass (*Panicum virgatum*), Red-top (*Sporobolus airoides*), Blue-stem or Blue grass (*Agropyrum glaucum*), antelope grass (*Muhlenbergia gracillima*), Buffalo grass (*Buchloe* sp.), wild licorice (*Glycyrrhiza lepidota*), bottle brush, squirrletail, fringed and Bigelow sage, thistles, loco weed, vine mesquite, mullein, Indian paint brush, rabbitbrush, yucca, Palmer amaranth, pinyan, juniper and various wildflowers. Also present are invasive non-historic plants such as snake weed

(*Gutierrezia sarothrae*), sagebrush, oak, wolftail, threeawn and silver bluestem,¹² and the Fiesta daisy or annual sunflower (*helianthus annuus*) to name a few.¹³ Sandstone flagstone walks, sandstone foundations and remaining brick floors are in constant contact with potentially damaging vegetation. On average, vegetation covers approximately 30% of the building complex.

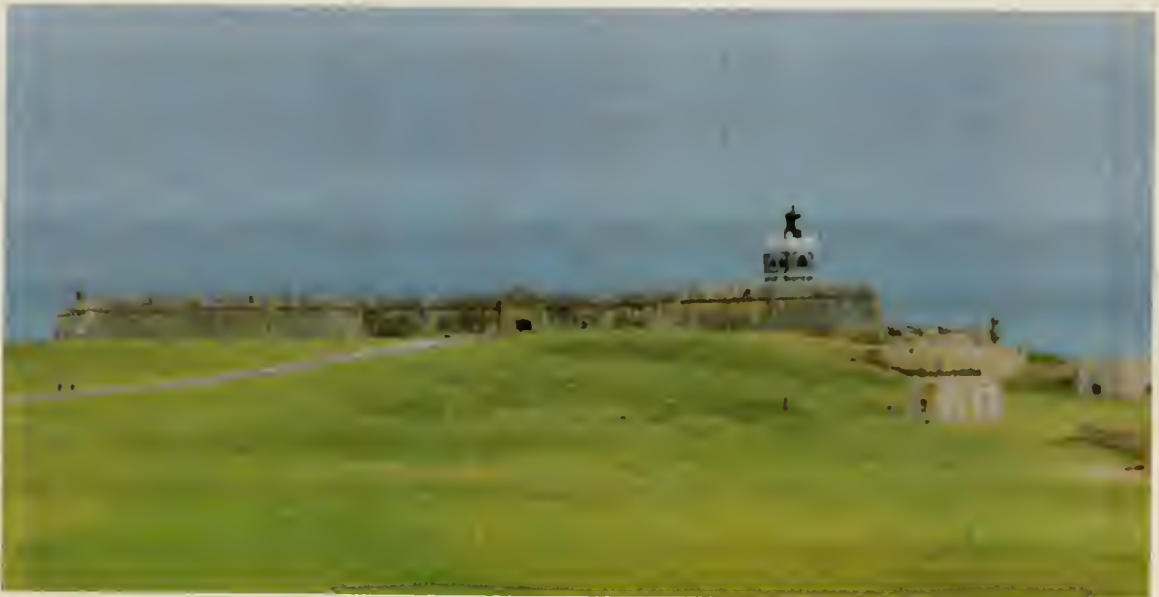
Figure 5: *Castillo de San Felipe del Morro, San Juan, Puerto Rico*

found including *Fusarium oxysporium*, *Mycelia steritia* (Hyahine), *Mycelia steritia* (Dane) and *Cladosporium cladosporioides*.²⁶ The historic stones provide nutrients and a foothold for such microflora as well as for higher plant forms. Many types of tropical plants are found growing on the Fortification walls. Typical weeds found in the area are common plantain (*Plantago major*), common sowthistle (*Sonchus oleraceus*), Mexican pricklypoppy (*Argemone mexicana*), and fetid passionflower (*Passiflora foetida*). Other herbaceous growth may include balsam torchwood (*Amyris balsamifera*), (*Bucida tetraphylla*), gumbo limbo (*Bursera simaruba*), (*Clausia rosea*) and West Indian milkberry (*Chiococca alba*).²⁷ A full survey of plant species has not been undertaken. Most growth is found on areas that are not covered by stucco. On some wall sections, the growth is sparse while on others it completely covers the historic masonry wall. Extent of exposure and water content are the main reasons for this variation. The large cavities of the stone provide a place for seeds and spores to settle and germinate. Plants grow in the mortar joints, cracks or cavities in the stone and along the foundation walls.

In addition to the damage caused by roots, excess moisture can be seen running down the face of the wall beneath clumps of plants. Shade from plants

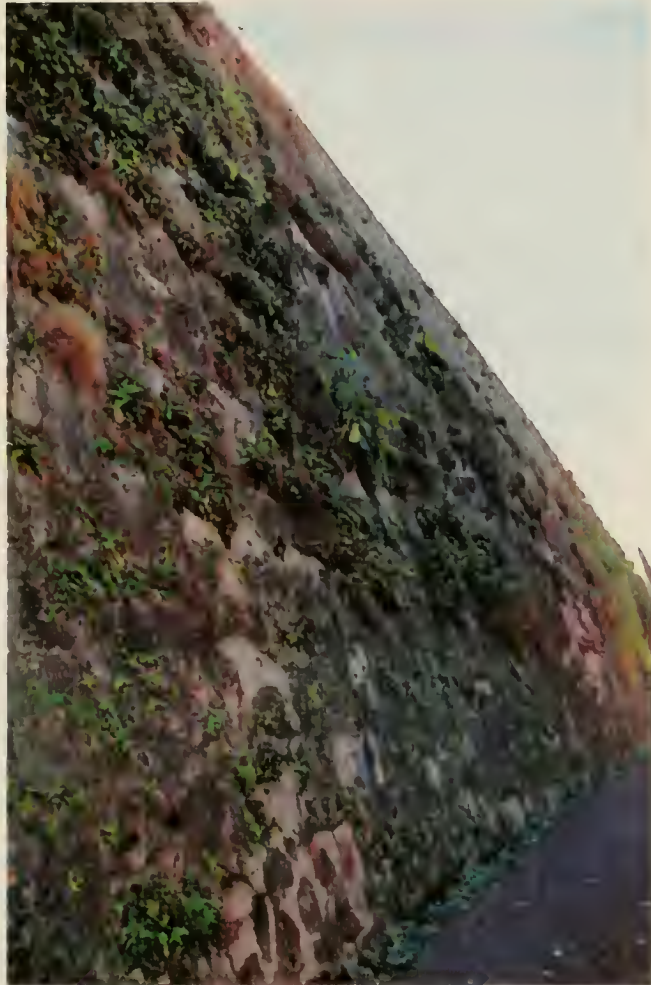
Figure 6: Extensive vegetation on San Juan Fortification Walls

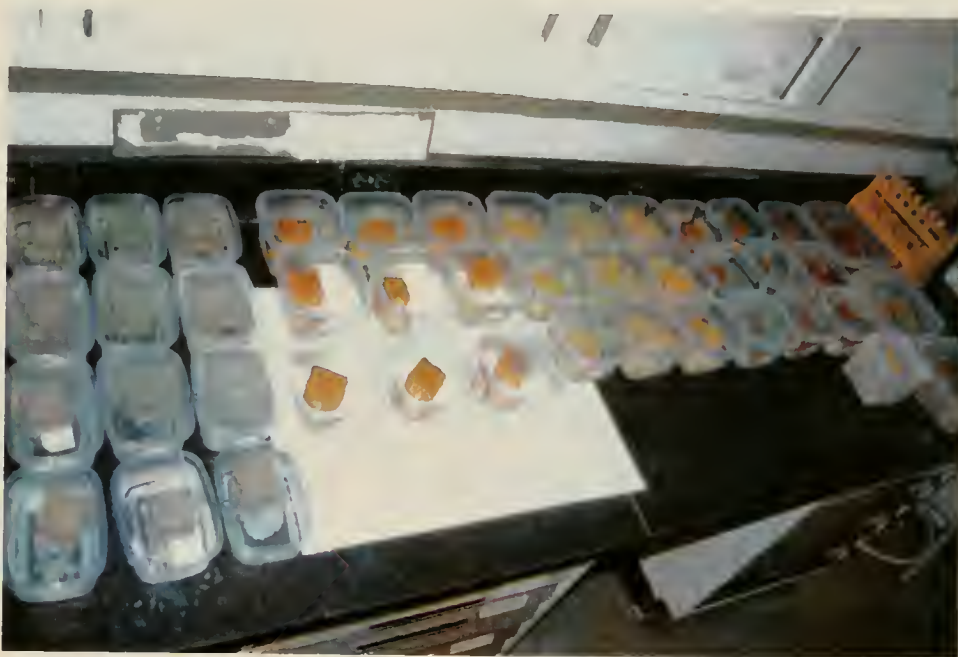
Figure 8: Immersion of samples

concentrated Round-up® herbicide mixed with tap water to the manufacturer's recommendations making a solution of 17% Round-up® in water. The fourth solution was Round-up® mixed with tap water to a concentration double the manufacturer's recommendations to increase the speed and intensity of reaction (34% solution of Round-up® to water). While Round-up® has been proven

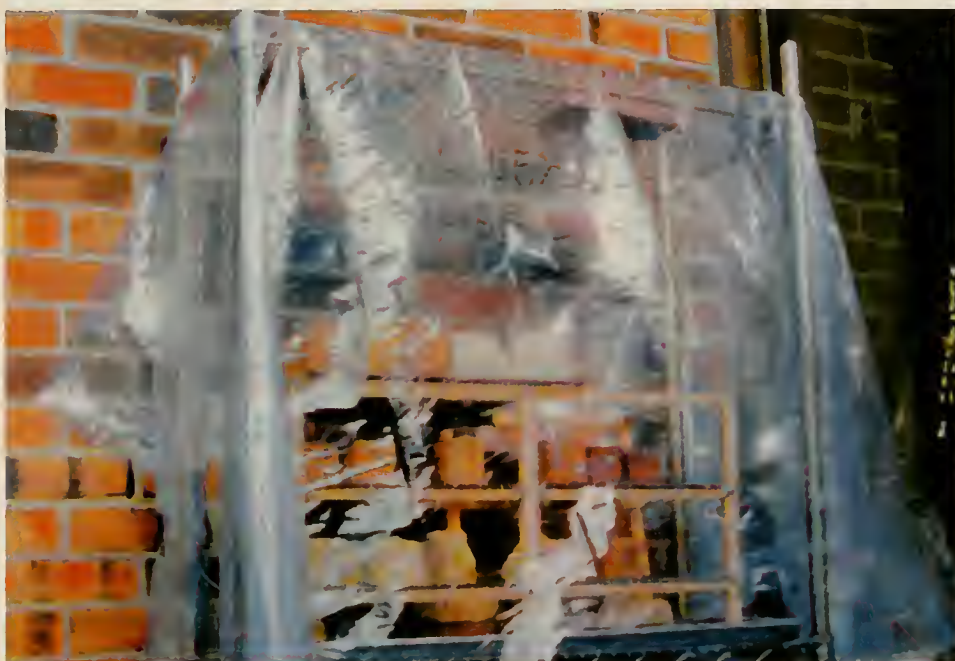
Figure 9: Samples drying outside

To simulate more realistic conditions, the stones were air-dried outside the Architectural Conservation Laboratory at the University of Pennsylvania. The

temperature ranged from 18°C to 32°C and the average relative humidity in June was about 64%. A protective chamber using a plastic drop cloth was designed to protect the samples from inclement weather.

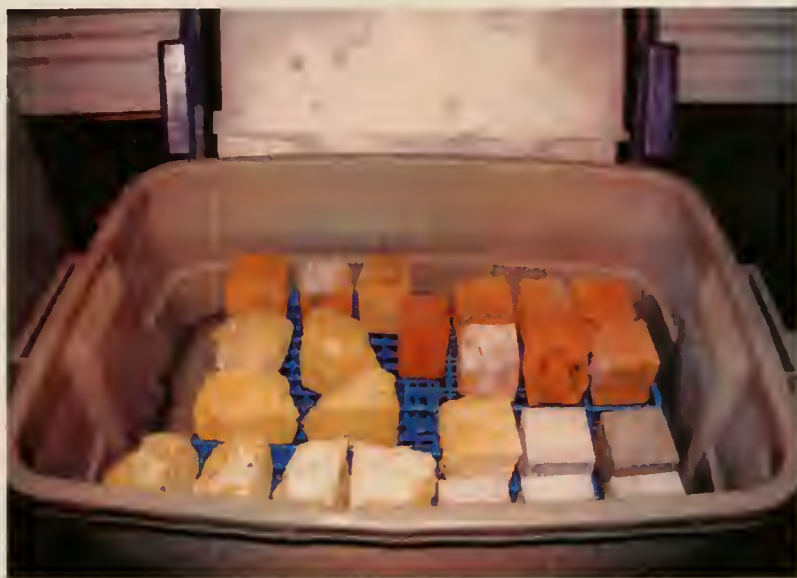
Figure 10: Stones in 100% Relative Humidity Chamber

Additional tests included hygroscopicity measurements to determine if the use of an herbicide would increase the attraction between water vapor and the stone. Hygroscopicity is the ability of a stone to absorb water vapor from the surrounding air. The porosity and water absorption capacity can affect the ability of the stone to absorb water vapor. The presence of soluble salts can also affect the hygroscopicity. After reaching a constant weight, the stones were placed on

racks in a plastic tub with 3.5cm of water in the bottom to create an environment of 100% relative humidity. The lid of the tub was covered with paper towels to absorb condensation and to prevent it from falling onto the samples. The tub was then sealed with duct tape. The samples were weighed weekly to measure the water adsorbed.

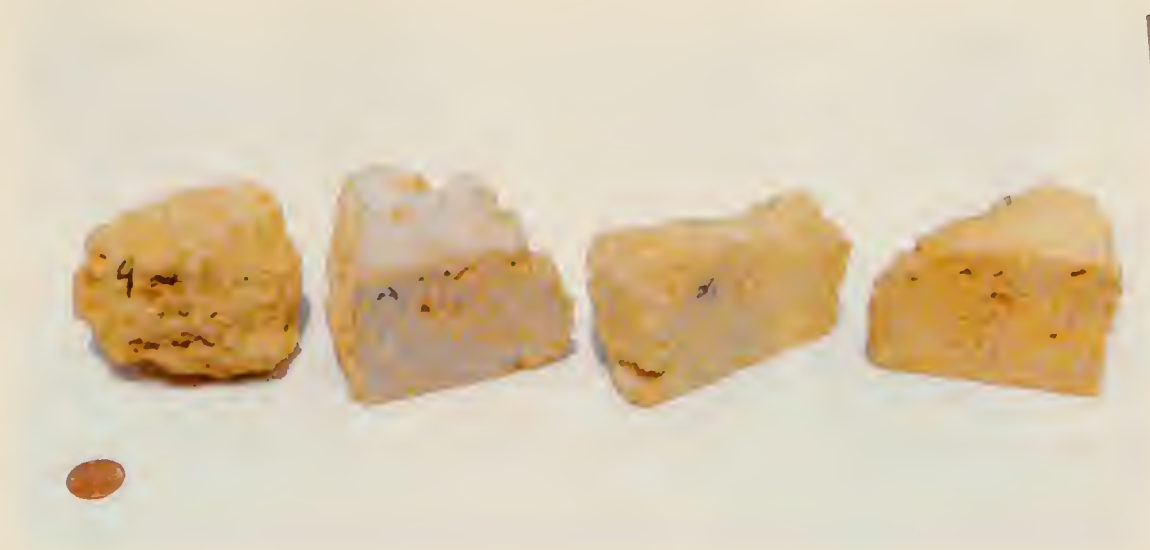
Figure 10: San Juan sandstone from left to right: immersed in tap water (I), surfactant solution (A), 17% herbicide solution (a) and 34% herbicide solution (2)

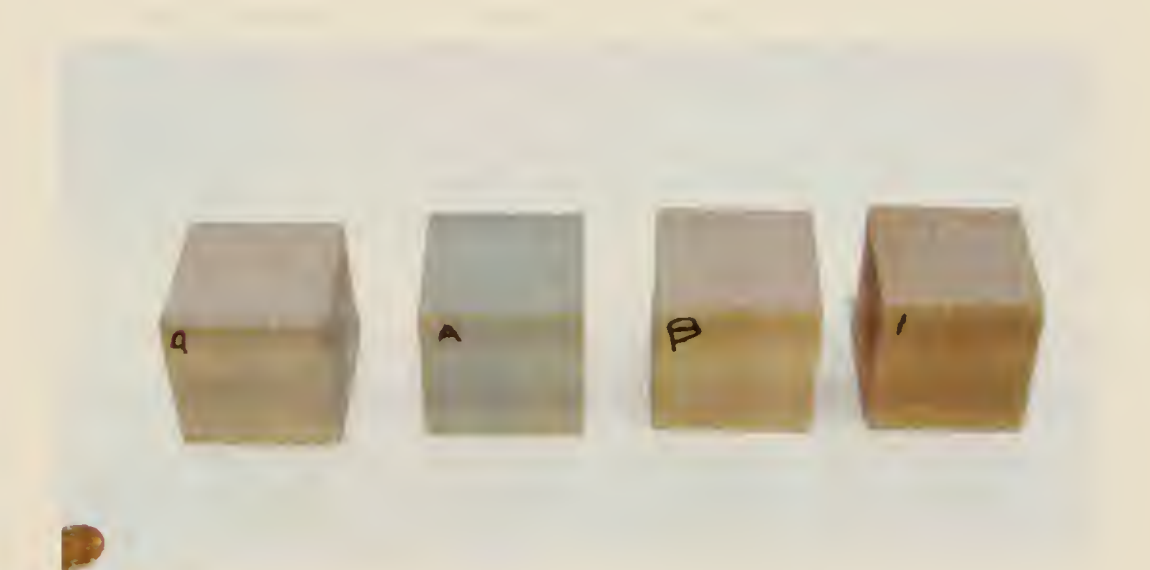
Figure 11: Indiana limestone from left to right: immersed in tap water (I), surfactant solution (A), 17% herbicide solution (b) and 34% herbicide solution (1)

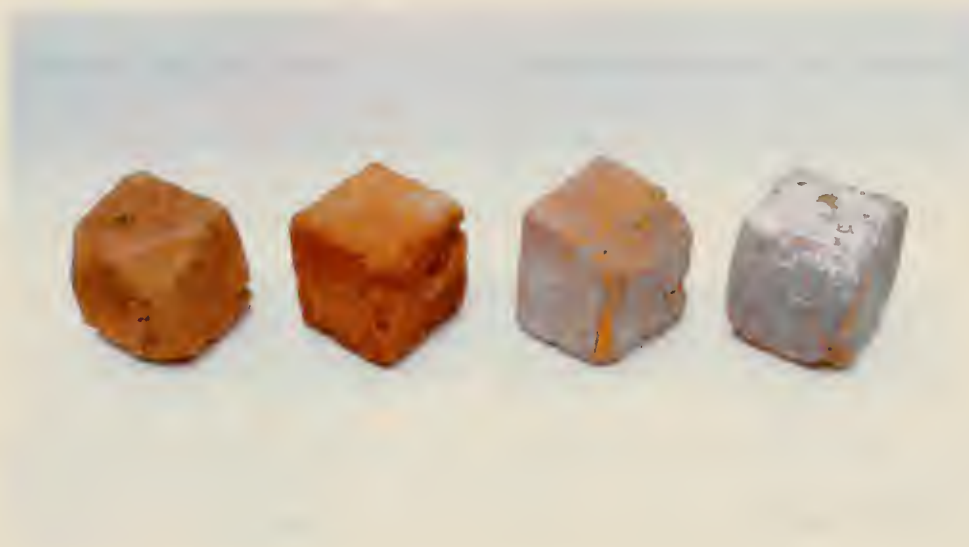
Figure 12: Fort Union brick from left to right: immersed in tap water (I), surfactant solution (A), 17% herbicide solution (a) and 34% herbicide solution (2)

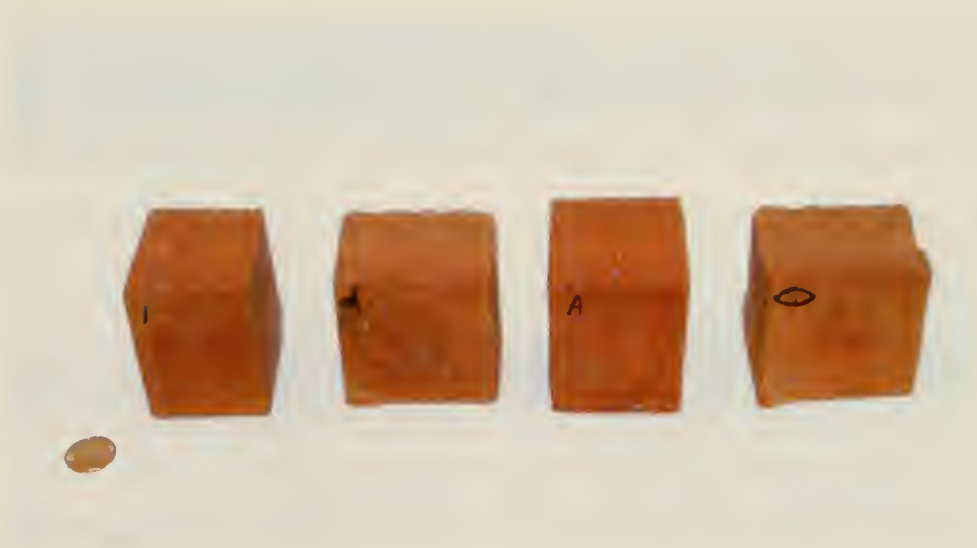
Figure 13: New brick from left to right: immersed in 34% herbicide solution (1), 17% herbicide solution (a), surfactant solution (A), and tap water (R)

There was little visual change in the new brick. No visible salt crystals formed. A salt haze appeared over portions of the bricks immersed in the herbicide solutions. Calcium carbonate particles in the brick powdered after immersion in the herbicide. The surface on the fireskin felt slightly smoother, a result of minor surface loss. There was no visible color change.

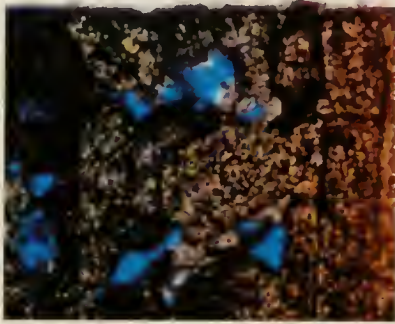
Figure 14: Surface of Indiana Limestone immersed water

In petrographic examination, the limestone was also noticeably affected by the different solutions. All samples, even those immersed in tap water, showed an increase in the amount of visible pores in the matrix. Small amounts of material were lost while soaking in tap water and the surfactant solution. Larger amounts of lost material were seen in the samples immersed in the 34% solution, which can, once again be attributed to the acidic glyphosate. When

comparing the two surfaces from the limestone sample immersed in the tap water and the limestone sample immersed in the 34% solution of herbicide, it is clear that there was significant surface loss.

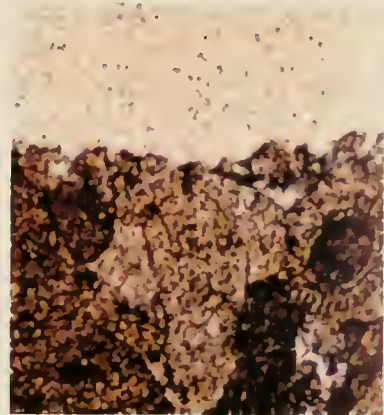
Figure 15: Surface of Indiana Limestone immersed in 34% herbicide solution

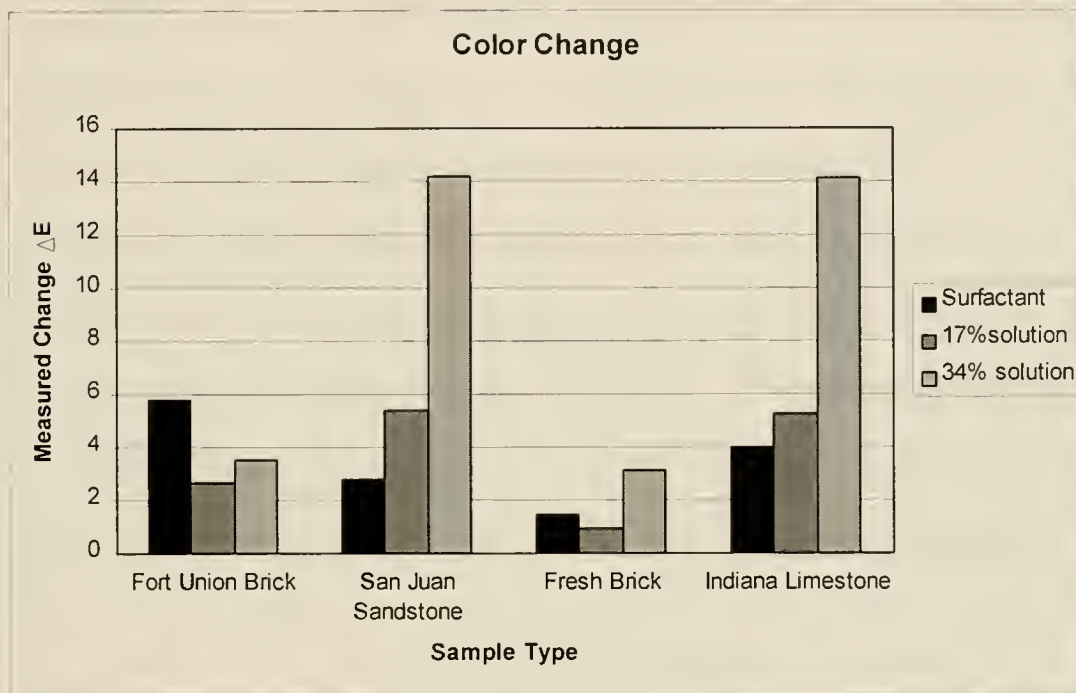
Figure 17: Color change in samples

The samples immersed in the tap water were used as the control for the color change measurements and are highlighted with gray on the chart. Minor color changes were detected in all the solutions with major color changes occurring in the 34% solution. A number recorded at 5 or above in the ΔE column indicates a clearly visible color change. Sample C from the Fort Union brick appears to be a color change but is not because a darker colored brick was originally used in the surfactant solution. The color changes seen are likely to be a function of the

low pH of glyphosate as evidenced by the author in an acid solubility test on similar samples.

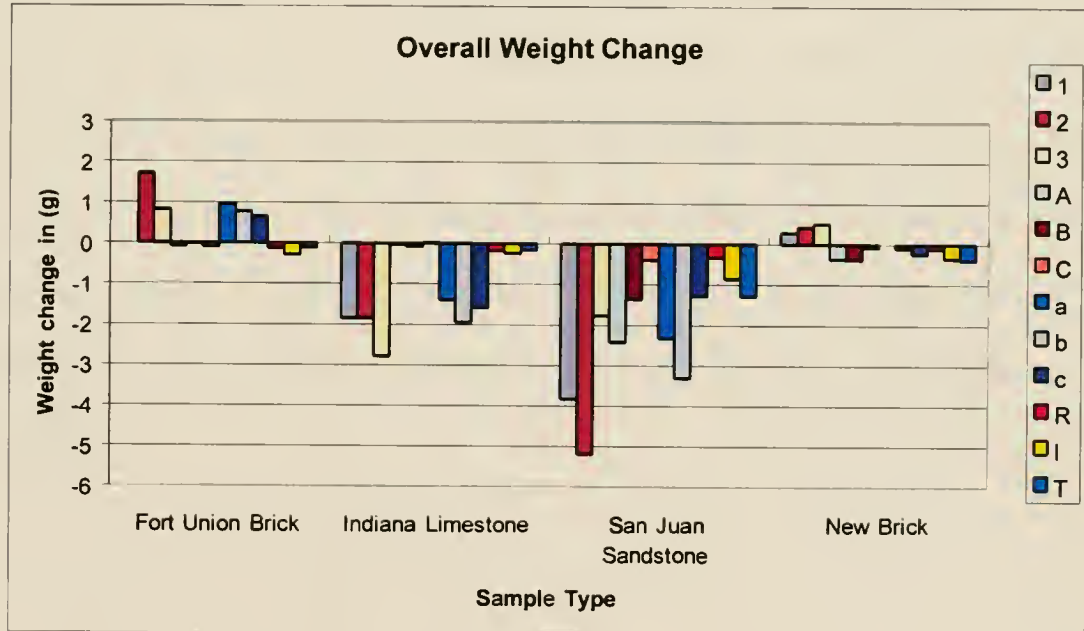
Figure 18: Graph illustrating overall weight change, note the weight loss of the sandstone and the limestone

Overall, there was some weight change in all the samples. The samples were weighed before and after treatment. Residual material remained in the solution containers from the samples and from the formation of the insoluble calcium complex that is characteristic of glyphosate. By subtracting the weight (post-treatment) from the weight (pre-treatment) and then subtracting the weight of the residue, a total weight change was determined.

Both the San Juan sandstone and the Indiana limestone showed loss in all solutions. This is due to the friable nature of the natural stone and its susceptibility to acid. The sandstone, a poorer quality stone, had the most significant weight loss. The Fort Union brick gained weight in the two herbicide solutions. This may be attributable to the excessive salt growth covering the sample. The weight of this brick may have been less affected by the herbicide because it is fired at high temperatures sintering the clay minerals with a stronger bond than that found in the natural stone. The herbicide had little effect on the fresh brick. All weight change of the new brick was calculated to less than a gram, a very insignificant amount. However, the fresh brick did gain a

amount of weight in the 34% solution which may be attributable to salt deposits. Detailed measurements may be found in Appendix C.

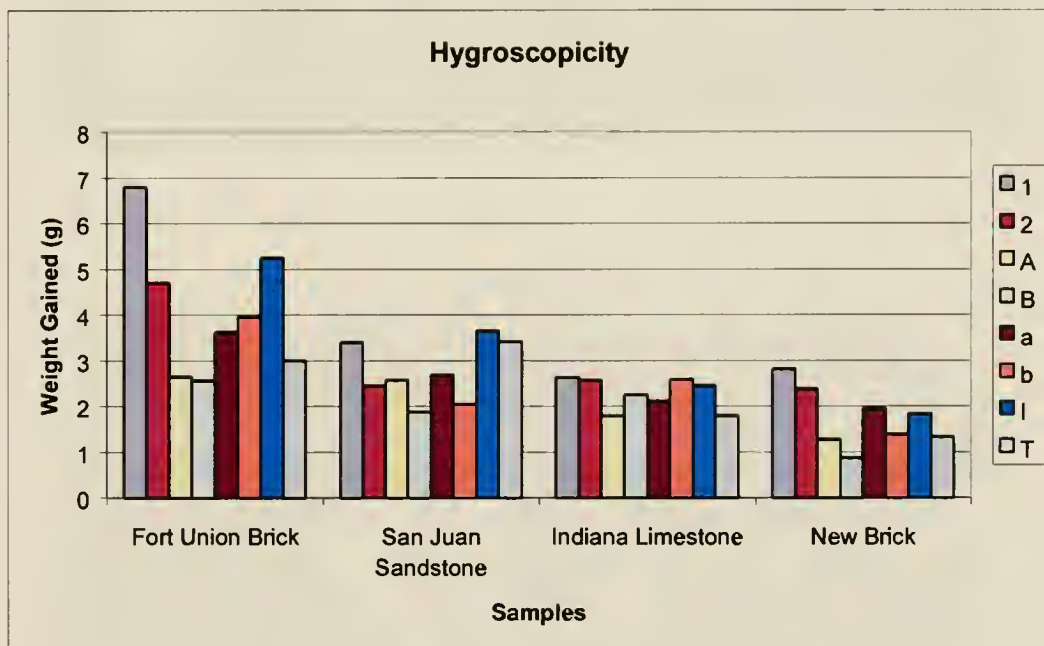
Figure 19: Chart illustrating hygroscopicity measurements of each sample tested

The stones immersed in the 34% herbicide solution were only slightly more hygroscopic than the tap water solutions. The herbicides immersed in the surfactant showed the least amount of water gain and the 17% solution samples were only slightly more hygroscopic than the surfactant samples. The most hygroscopic samples were the Fort Union bricks immersed in the 34% solution.

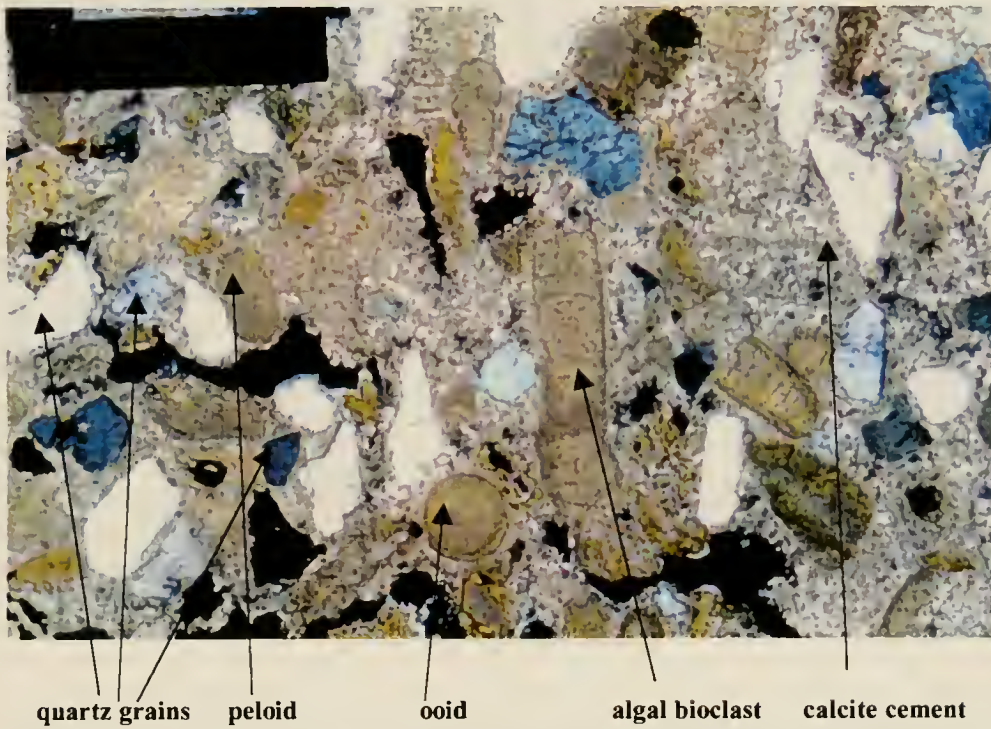
Figure 20: San Juan sandstone before treatment, 25X

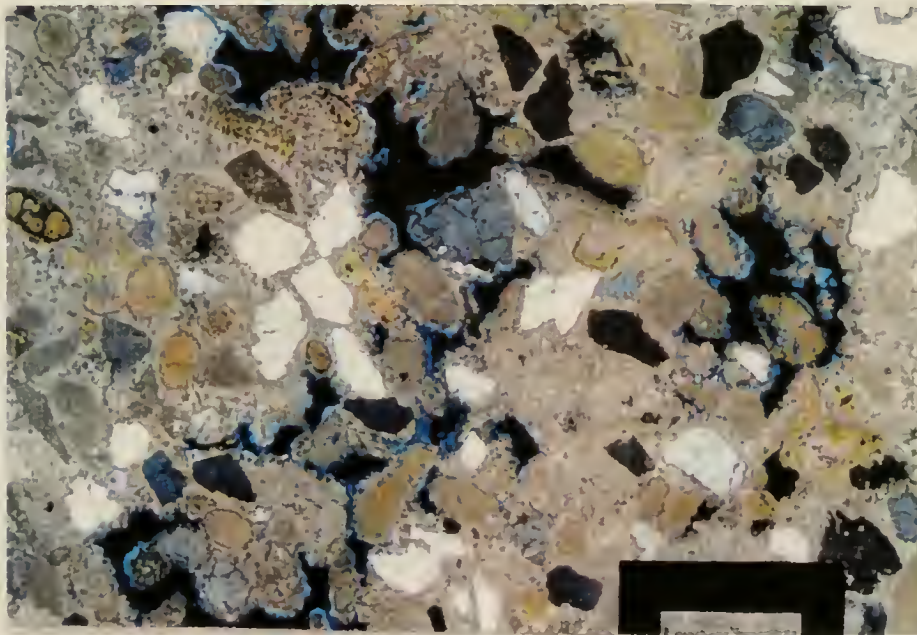
Figure 21: San Juan sandstone in tap water, 25x, Note increase in pore space and blue tinted salts

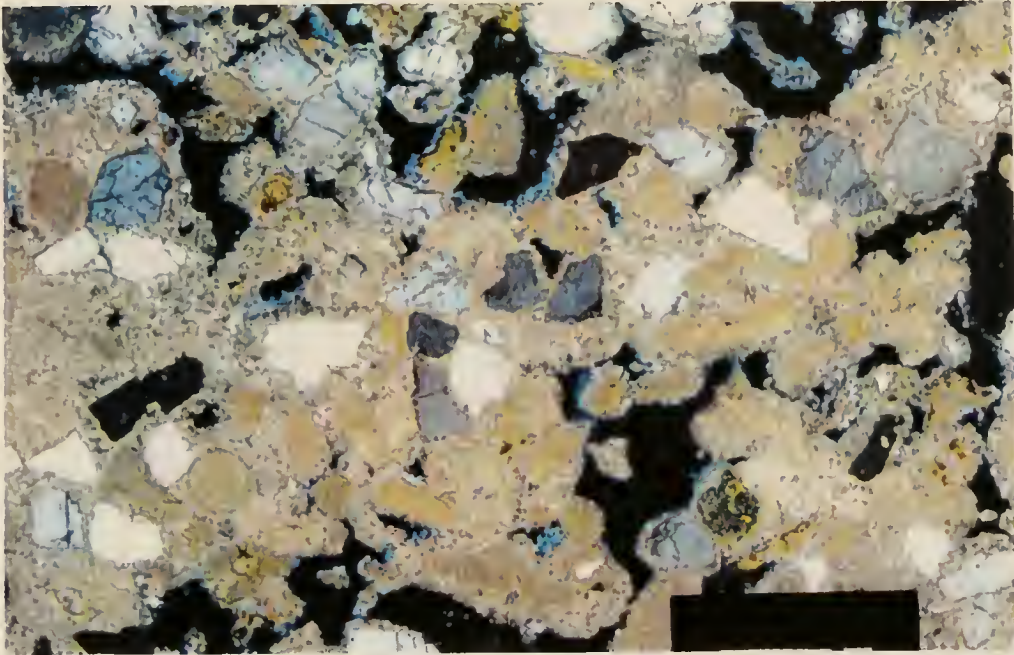
Figure 23: San Juan sandstone from surfactant solution, 25X, Note results similar to tap water solution

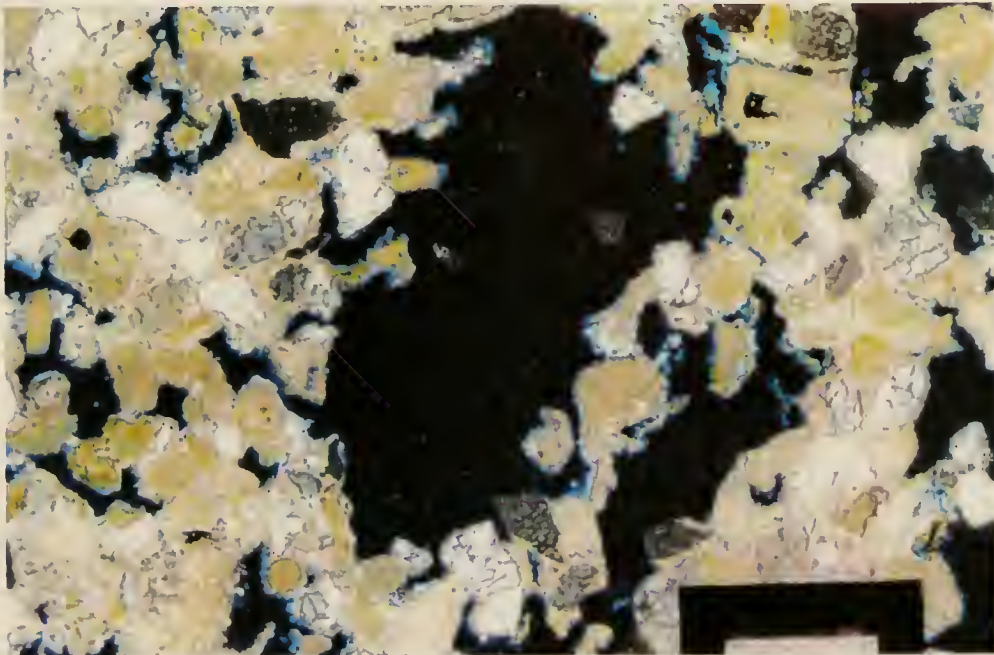
Figure 24: San Juan sandstone immersed in 34% Round-up® solution, 25X, Note larger pores, loss of calcite cement and salt deposits

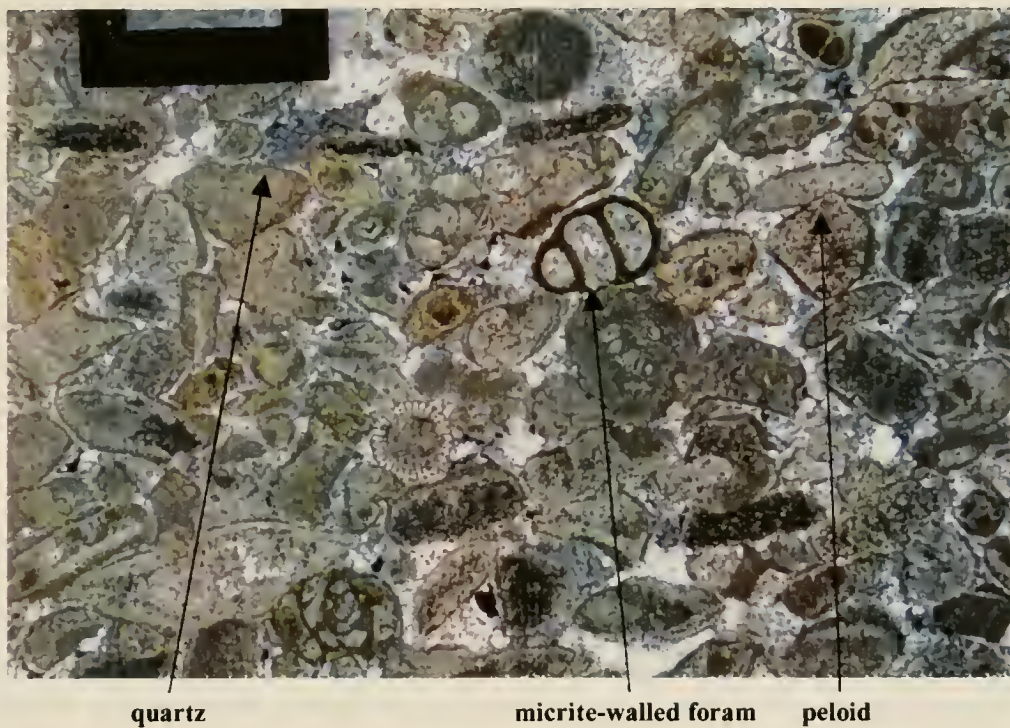
Figure 25: Indiana limestone before treatment, 25X, Note low number of pores and high quantity of allochems

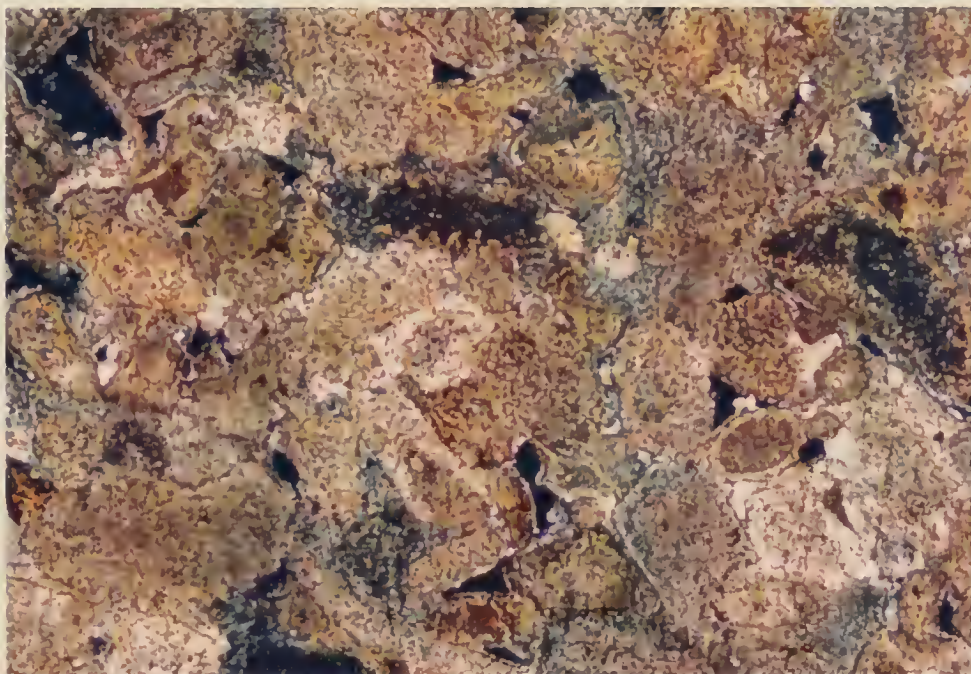
Figure 26: Indiana limestone immersed in tap water, 50X, Note increase in pore space

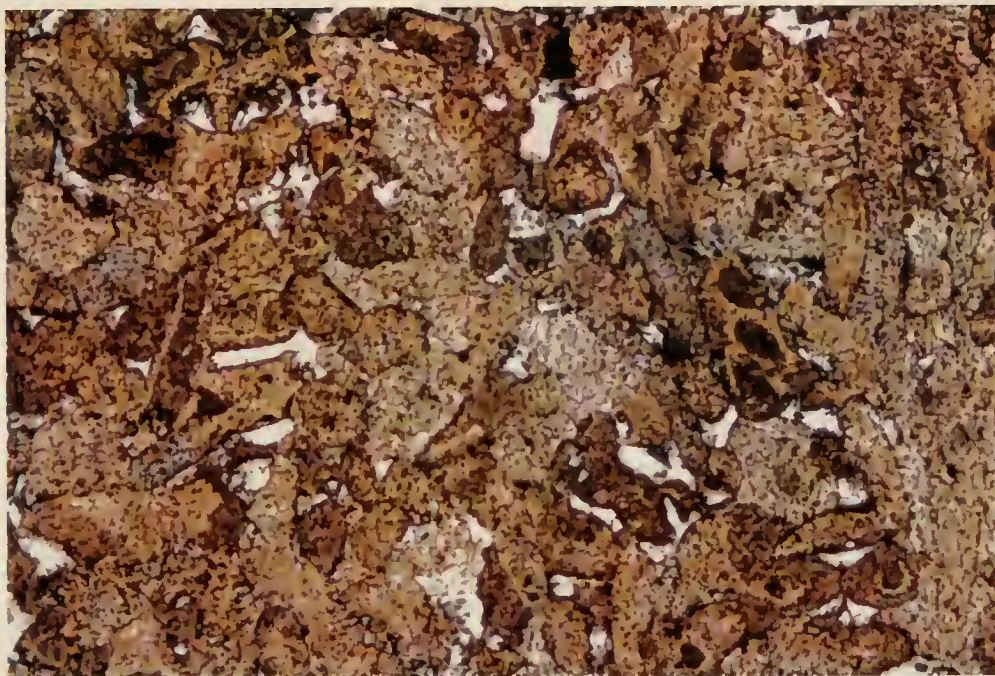
Figure 27: Indiana limestone immersed in surfactant solution, 50X, Note increase in pore space

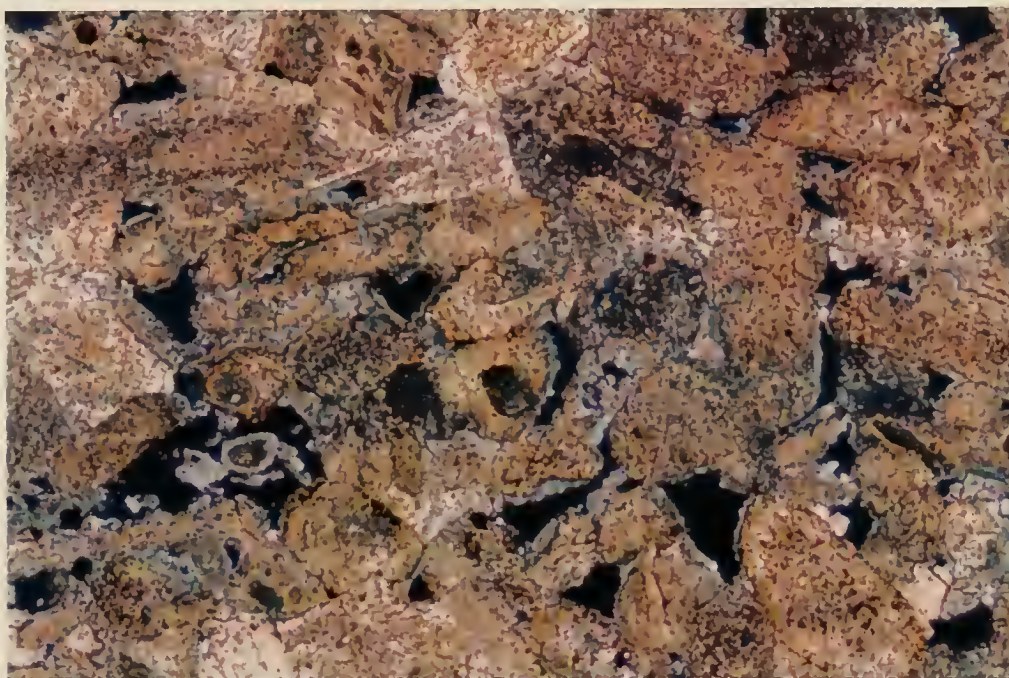
**Figure 28: Indiana limestone immersed in 34% herbicide solution, 50X,
Note loss of cement creating more pore space**

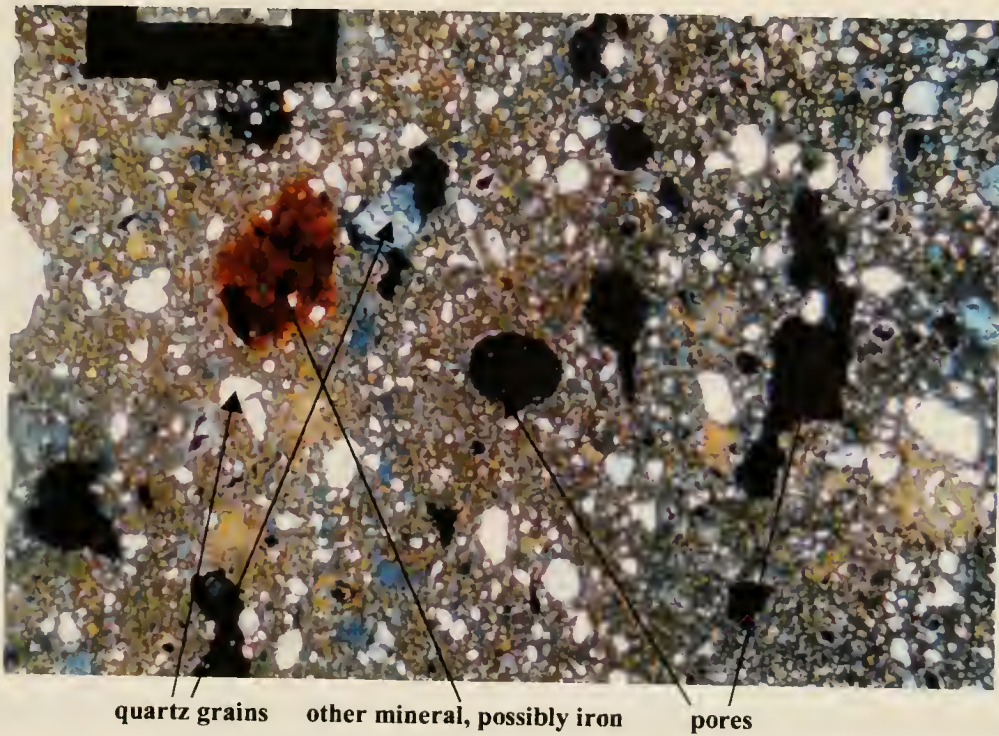
Figure 29: Fort Union brick before treatment, 25X

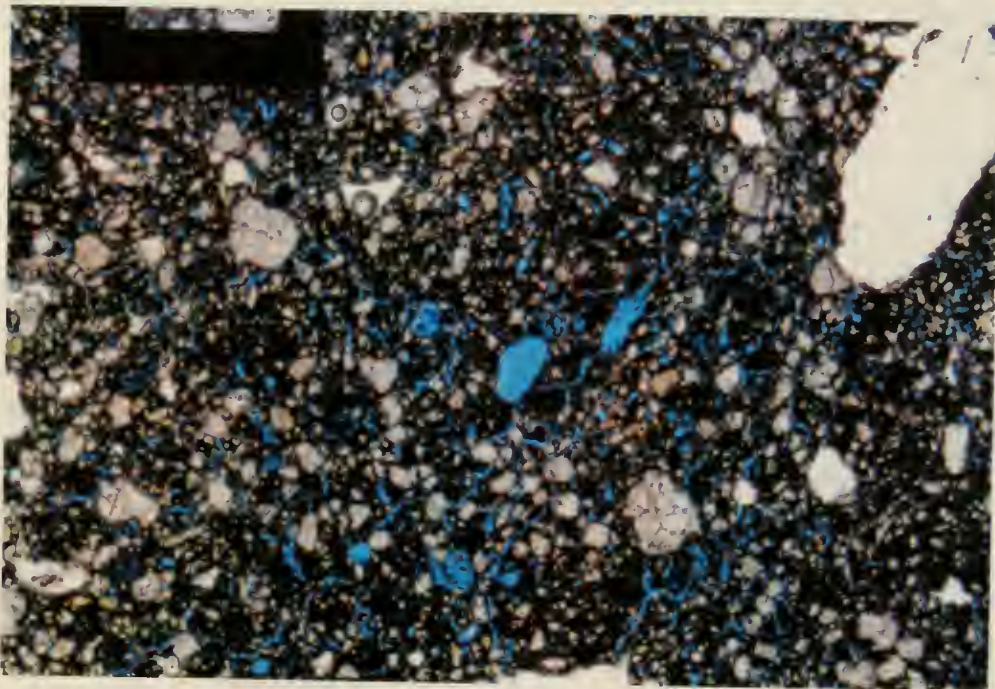
Figure 30: Fort Union brick immersed in tap water, 25X, Note small channels in clay matrix

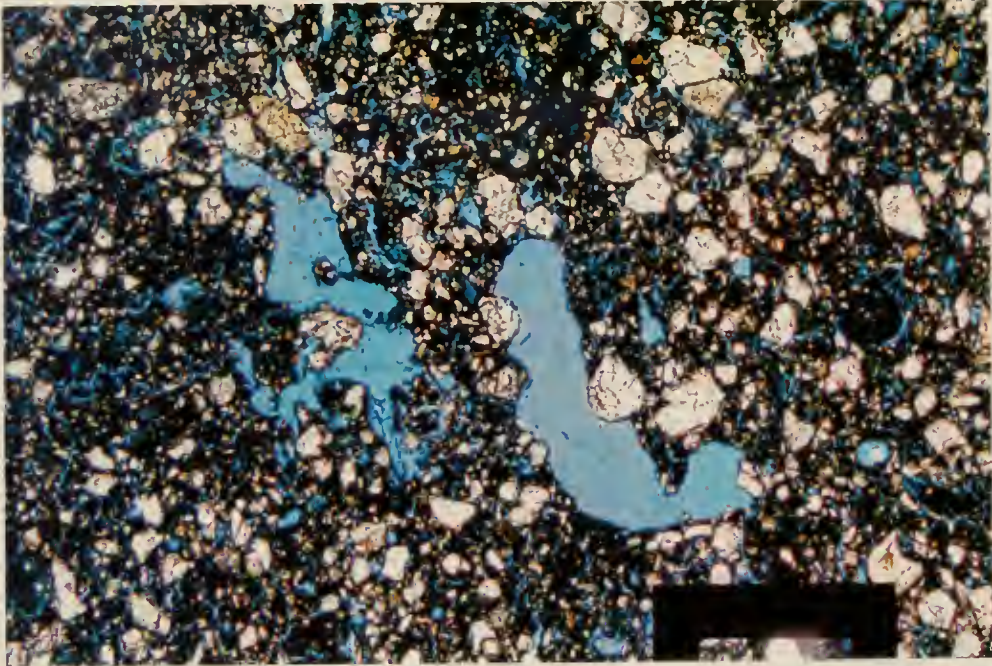
Figure 31: Fort Union Brick immersed in surfactant solution, 25X, Note small channels in clay matrix and pores similar to pre-treatment samples in size

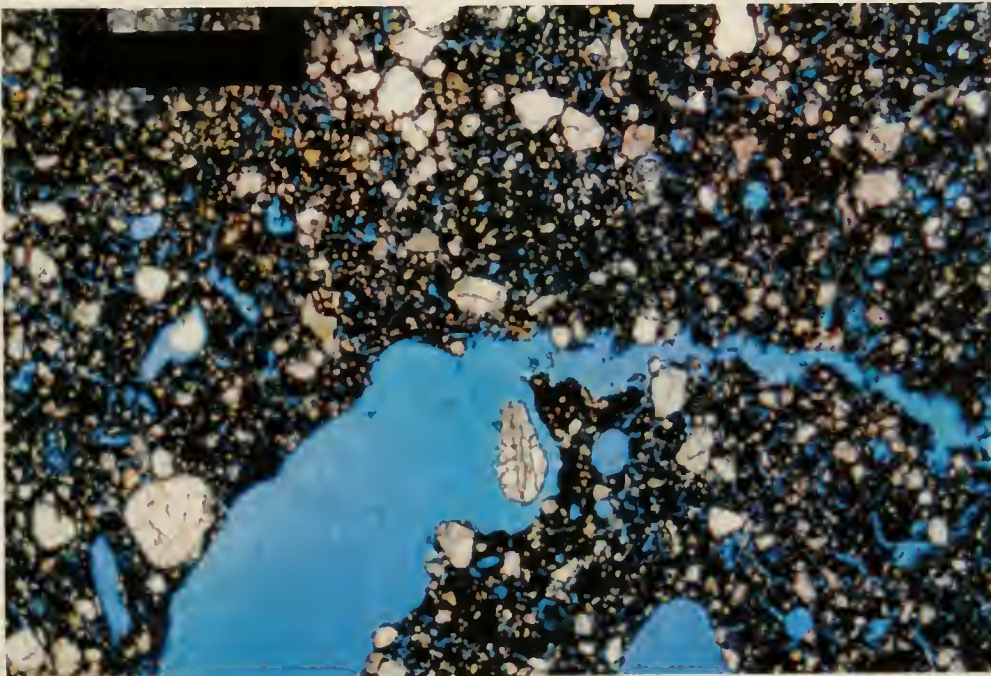
Figure 32: Fort Union brick immersed in 34% herbicide solution, 25X, Note formation of larger and smaller pores and channels

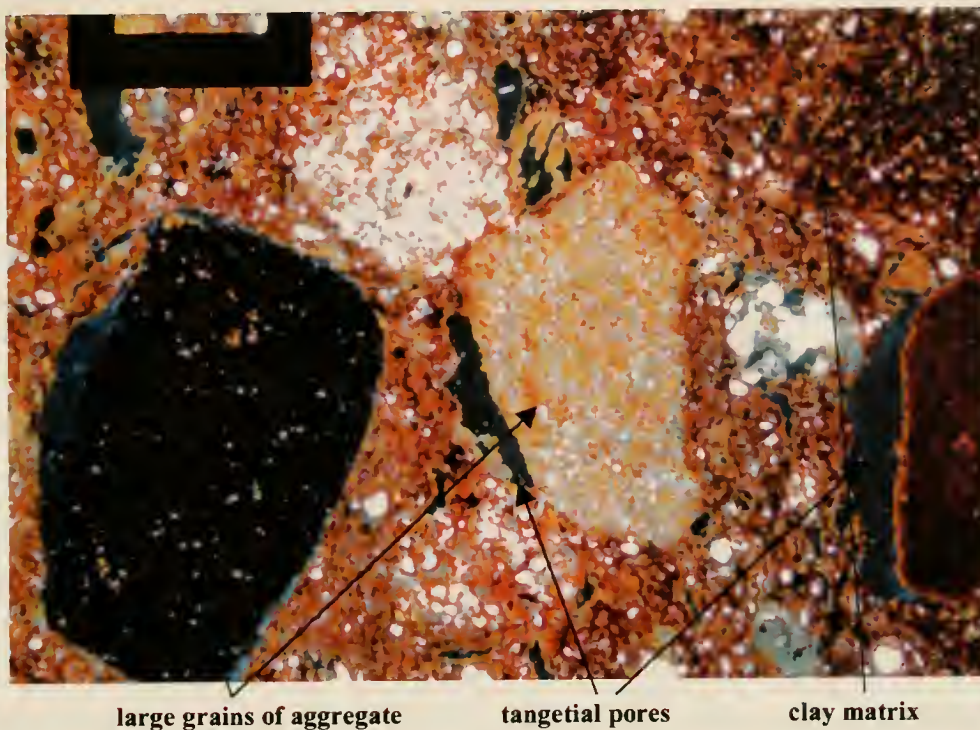
Figure 33: New brick before treatment, 25X

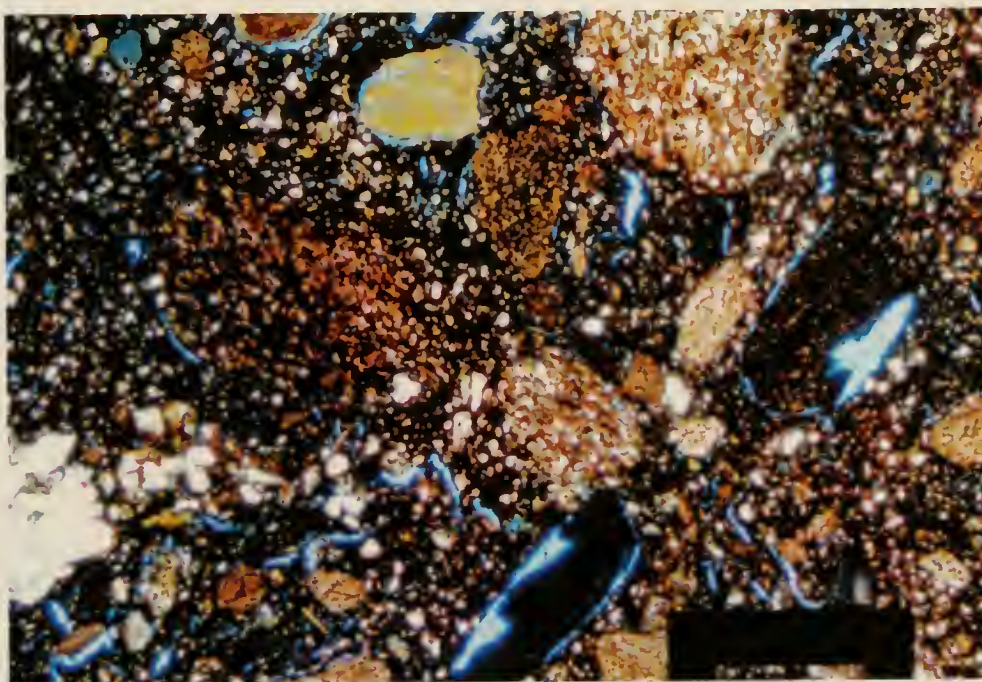
Figure 34: New brick immersed in 34% herbicide solution, 25X, Note little change in structure
